Fanuc Control – 086 Alarm Resolution.

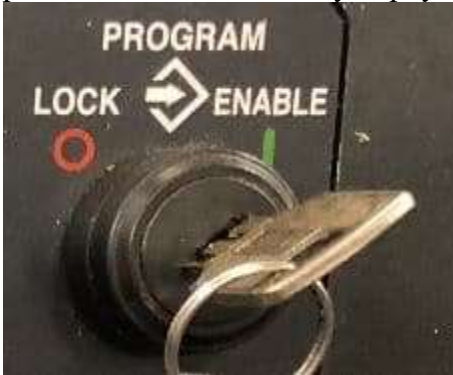
- Make sure the program edit key is not turned on. This would be a key on the control panel of the machine that you physically turn.

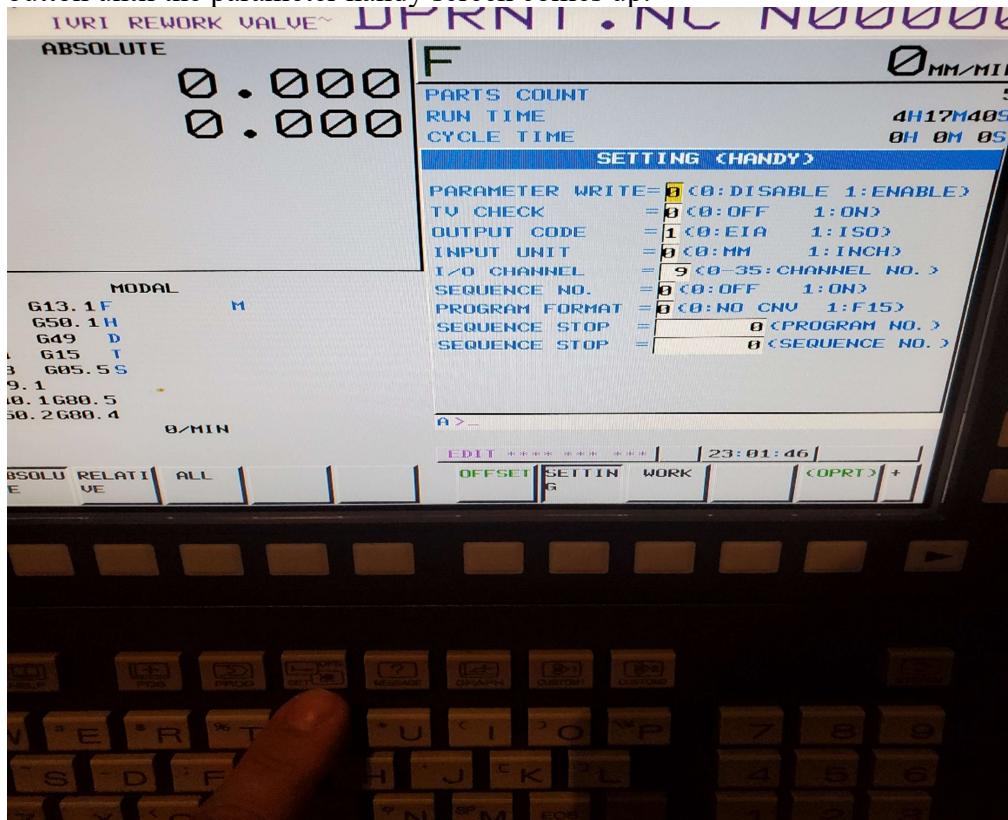
- Next, check the I/O parameter to make sure it is set to 0. To find this, press the offset button until the parameter handy screen comes up.

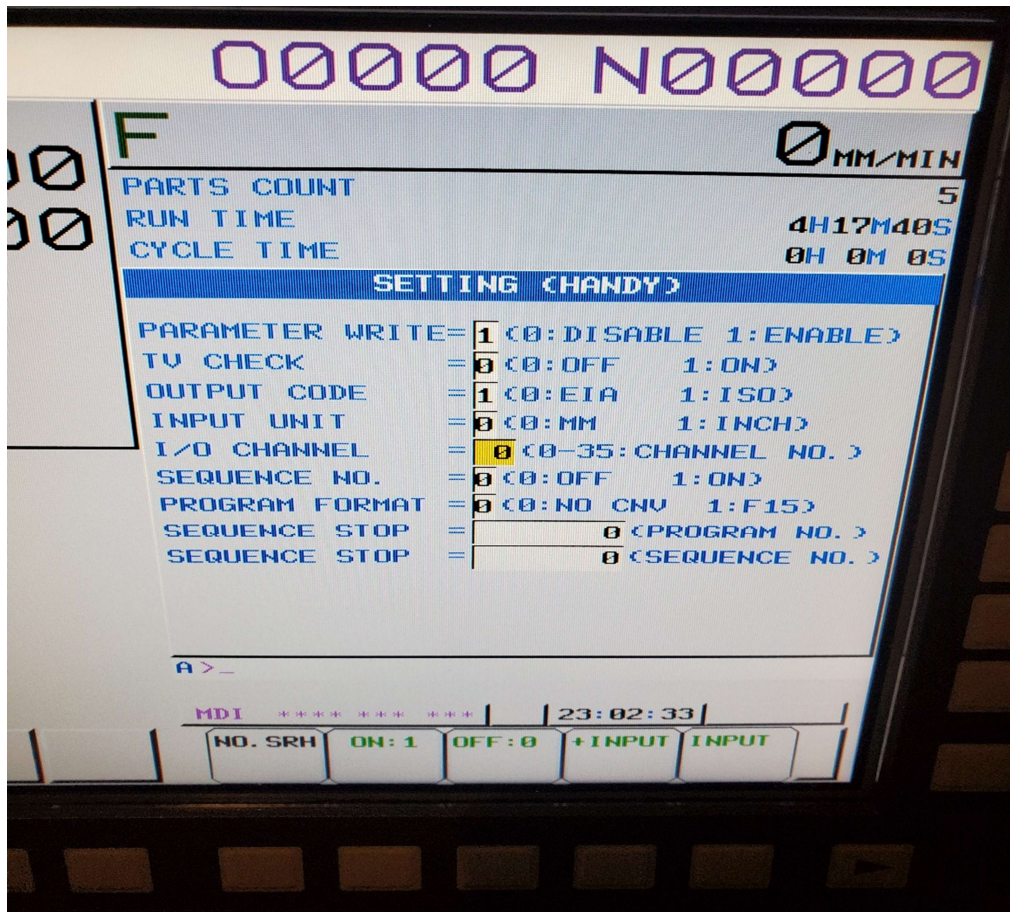
- Put the machine in MDI mode, change the first parameter to a 1 (it will give an alarm don't worry this is fine). Go back to the offset page and input a 0 for the I/O if it is not set.
